# Manhole Inspection Summary

Manhole # S07EE2015MH

**Location** Address: **2505 WETHERBURN RD** Cross Street: **GREENSPRING AVE**

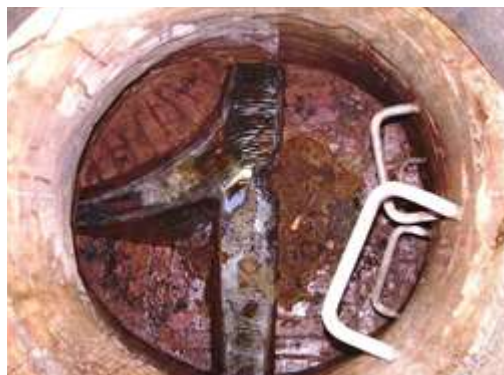
Top View

Evidence of surcharge - Bench debris.  
Channel debris.

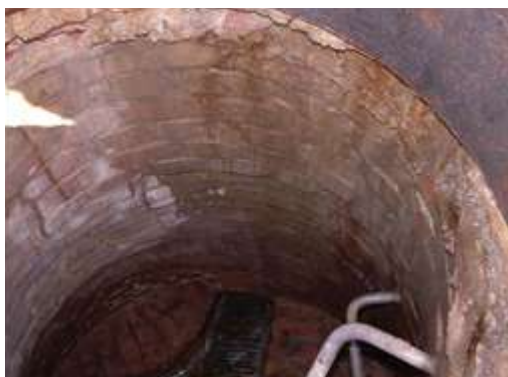
Defect

Frame leaks. Frame offset. Adjustment  
deterioration and infiltration. Corbel  
infiltration - other side.

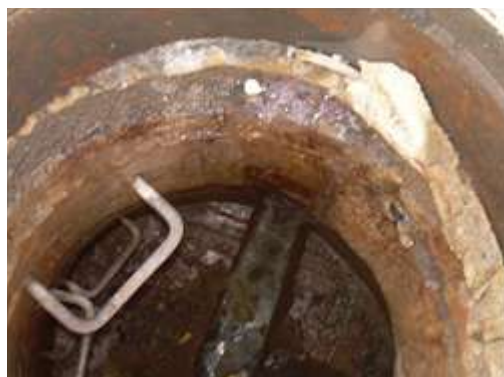
Defect

Frame leaks. Frame offset. Adjustment  
deterioration and infiltration. Corbel  
infiltration.

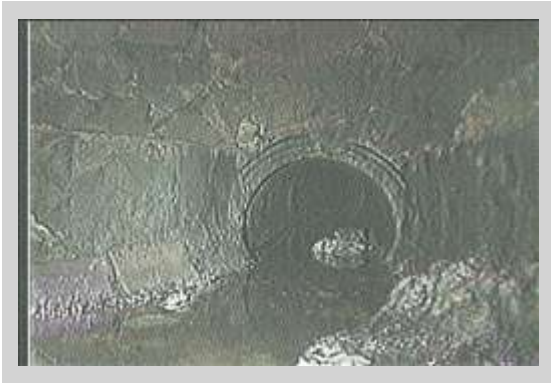
### 8 in. Circular Gravity Sewer Pipe Out @ 12 O'Clock

Deposits: ☐ None ☒ Mud ☐ Sludge ☒ Debris ☒ Grease

Silt Depth: **0** (in.) Deposits Extent: **Light**

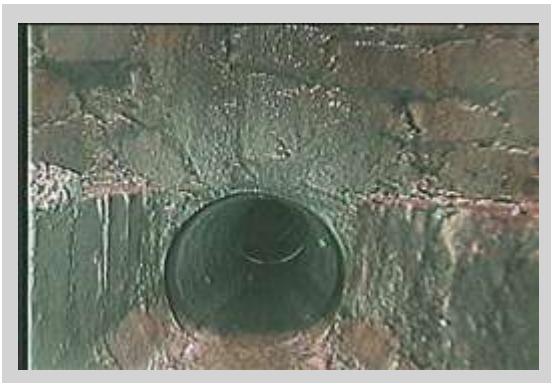
### 8 in. Circular Gravity Sewer Pipe In @ 6 O'Clock

Barrel deterioration and infiltration. Channel deterioration.

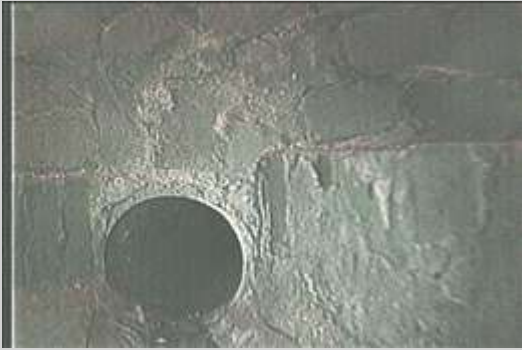
Pipe In @ 9 O'Clock

Barrel deterioration and infiltration.
